Earthquake Vulnerability Assessment of House Constructions in Himalayas

Abstract

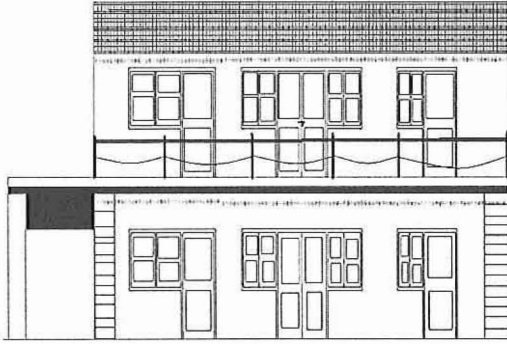
Figure 4:

- A: Front elevation of a typical double storey house
- B: Cross section of a typical double storey house
- C: Ground floor plan of a typical double storey house
- D: First floor plan of a typical double storey house

Villages of Narendranagar block are located on quiet mountains of Garhwal Himalayas. Agriculture is the main occupation; hence, these villages are located on comparatively low slope regions for the benefit of terrace farming. Areas of steep slopes are not occupied by villages. Houses are small and simple, built in continuous rows which increase the risk of earthquake damage (Figure 2). They are mostly single storeys but in many places double storey houses are also seen. The rooms of houses are usually small and placed in row. All rooms have at least one external door. In many houses there is no internal connection in the rooms. Floor height in general is small (about 1.8 - 2.4 m). The open space in front of the rooms is used as a utility space for household works. The sheds for cattle are usually located below the house on ground floor, adjacent to the house or in some cases near the house (Figures 3, 4).

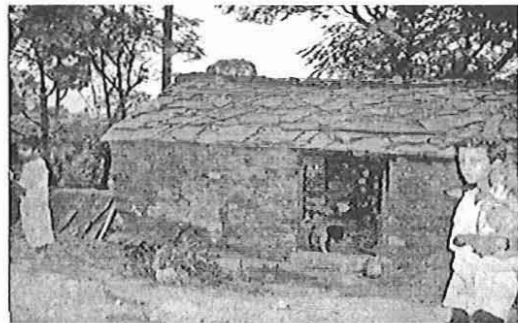
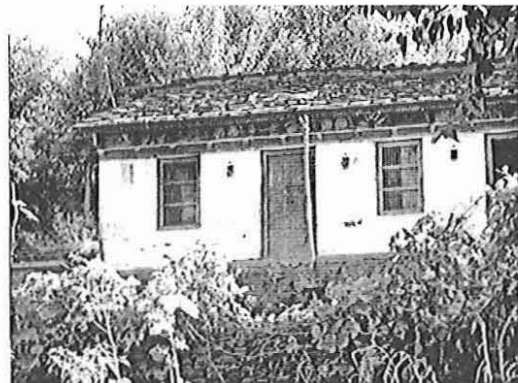
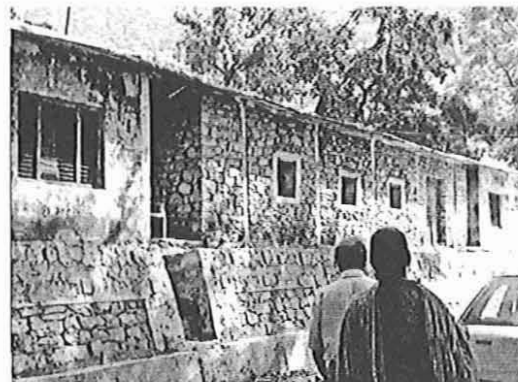
Figure 6: Stone walls

- A: Stone and slate masonry
- B: Random rubble stone masonry with cement plaster
- C: Stone in cement sand mortar with cast in situ RC slab

Stone and slate masonry: As seen in old houses, traditionally, the stone masonry is made up of large sizes of stone blocks laid in mud mortar. Many thin wafers of slate are filled in the depressions of large stones to create an "even" course and finished outer (exterior) surfaces (Figure 6A). The wall thickness can vary from about 450 to 750 mm consisting of two wythes. In well constructed houses where quality of workmanship is good, through stones are used frequently to bind both wythes.

Random Rubble (R/R) stone masonry: In general, Random Rubble (R/R) stone masonry has no layers of slates to fill in the undulating contours of large stones. These walls are composed of two wythes with total wall thickness varying from 450 to 750 mm. undressed stones are laid in mud mortar and plastered in cement – sand mortar to provide finished surface. (Figure 6B)

Stone in Cement Sand Mortar: Cement – sand mortar is not common for stone masonry: only a few government buildings, urban area dwellings and those along highways can be seen constructed with stone masonry laid in cement – sand mortar. Walls are thick up to 450 mm and the mortar mix is 1:6 or leaner. Floor and roof of these buildings are generally, cast in situ RC slab. (Figure 6C)

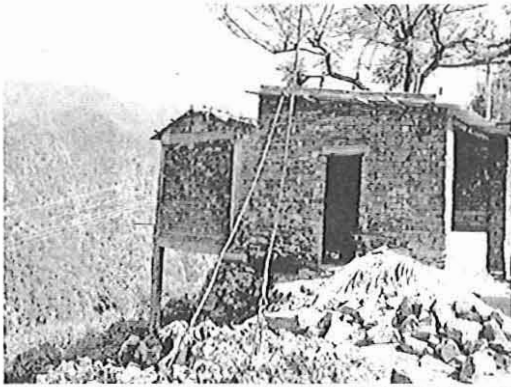
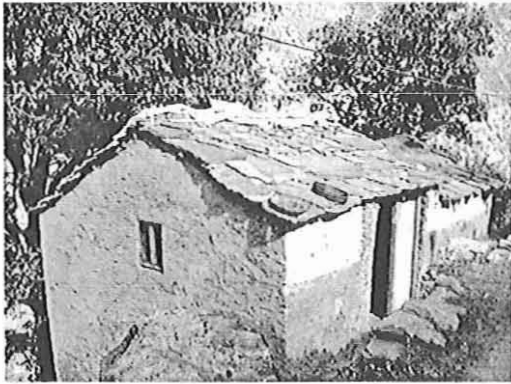
The performance of these buildings during earthquakes is related with the type of roof, the mortar used and the quality of construction. Performance has been poor with pitched roofs having no binding effect on walls, poorer with mud or weak mortars and still poorer with bad quality construction. Buildings with rigid slab roofs have generally behaved much better than others due to their binding effects on walls by diaphragm action by which lateral load is transferred to shear walls. Cracking is frequently observed in diagonal or cross form in the masonry piers between the openings (since clay bricks are much weak as compared to stones), vertical cracks near the corners leading to separation of perpendicular walls through toothed joints and horizontal bending cracks in the walls which are at right angles to the predominant direction of the earthquakes. Also, very minor damage to concrete block masonry walls was observed. (GSI 1992 and NSET and DEQ 2000)

Defects in the burnt brick or concrete block buildings

- Poor strength of material in tension and shear, particularly where mud mortar or lime – sand mortar weaker than 1:3 or cement mortar weaker than 1:6 is used.
- Toothed joints cause a vertical plane of weakness between perpendicular walls.
- Large openings and their placement too close to the corners can cause failures
- Very long rooms having long walls unsupported by cross walls fail in bending or overturning.
- Unsymmetrical plan of building, with too many projections. (BMTPC, 1992)

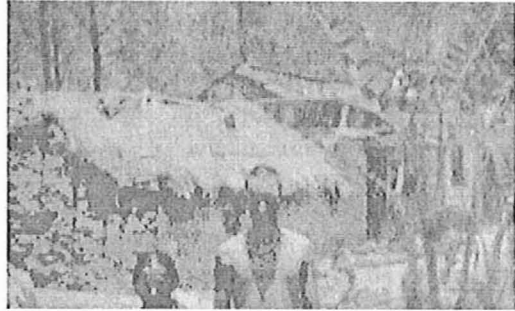
Figure 10: Thatch Roofs

Thatch roof: These roofs are constructed of thatch with timber frames. They are always used over small sized rooms with stone or earth walls. They are used for very poor households or cattle sheds. (Figure 10)
